COUNTRY East Germany

SUBJECT Vessels of the NVA/See in the Baltic

DATE OF REPORT 9 April 1958

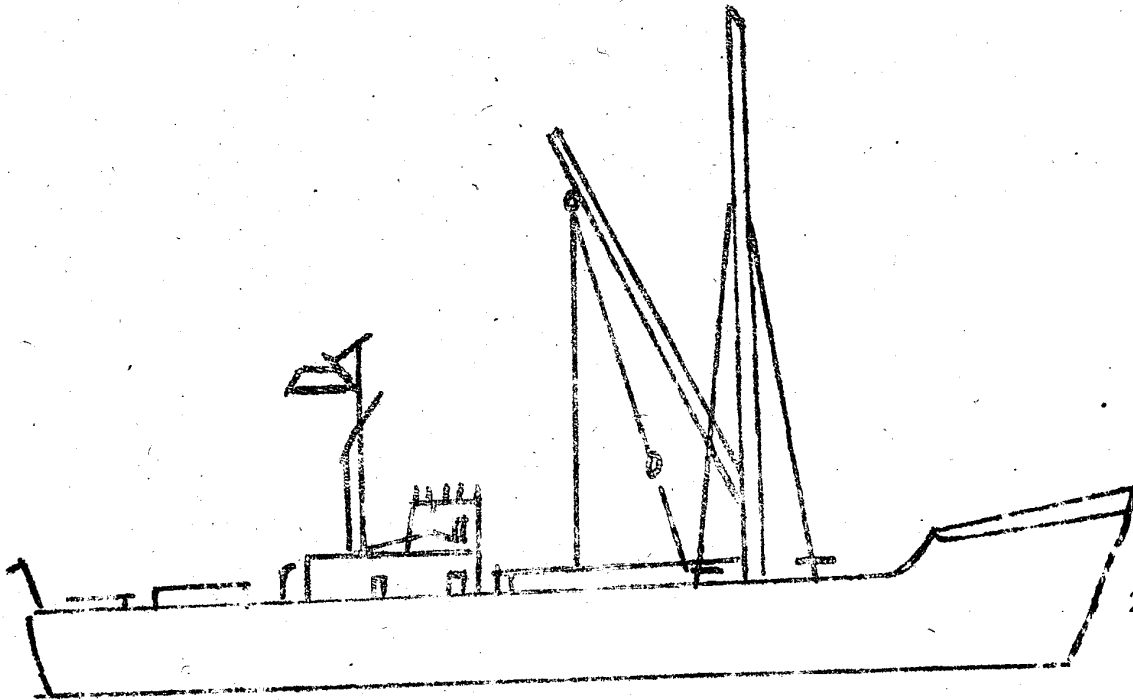
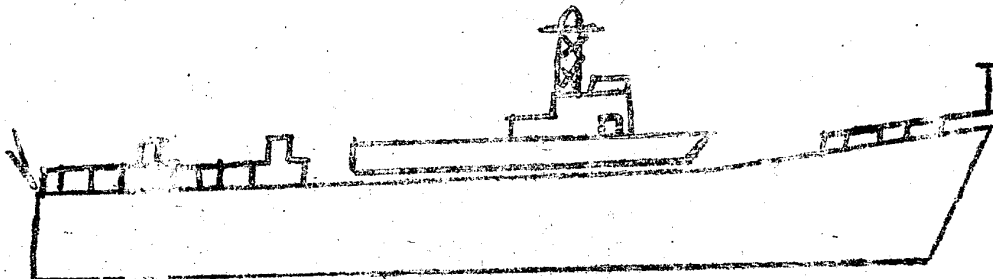
Description of the speedboat: Apparently of Soviet type, radar mast mounted on top of bridge house, short and bulky hull, high-sided, one torpedo tube on either side, approximately in the middle of the ship; Two canvas covered guns on quarter deck; and only a small anchor capstan and a small rail on the forecastle.  
 (See sketch).

Comment. The "tender" is believed to be a lighter for dry cargo of NVA/See.  
 The tugged speedboat presumably is one of the nine vessels of type P-6 turned over to the NVA by the Soviets.  
 The observation in this area is considered normal, (about 6 seamiles south-west of Gedser Rev).  
 For sketches, see Annex.
